**VOICE QUALITY TROUBLESHOOTING GUIDE
MITEL COMMUNICATIONS DIRECTOR RELEASE 6.0**

Voice Quality Troubleshooting Guide

Mitel Communications Director (MCD) Release 6.0
Rev. A

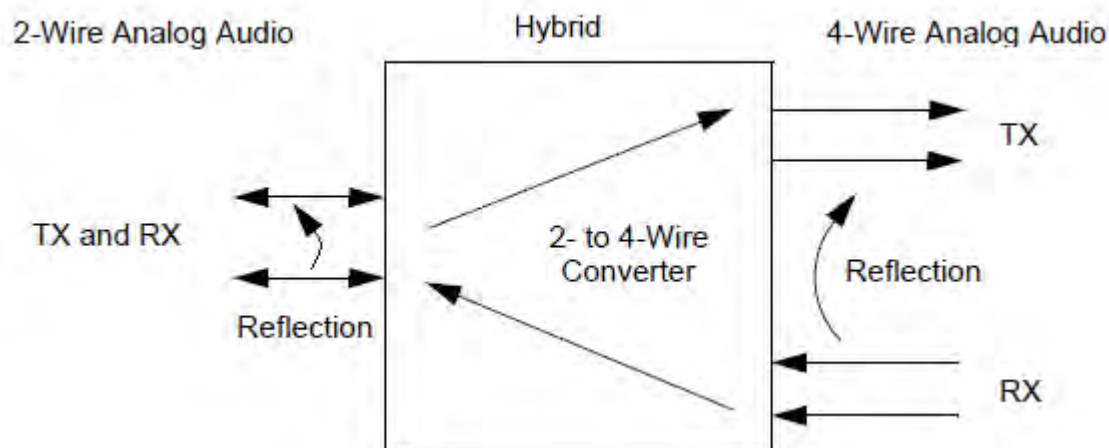
Two-wire analog audio refers to two physical wires (normally a twisted pair) where both the transmit (TX) and the receive (RX) audio are carried over the same physical pair of wires. Four wire analog audio refers to four physical wires where the TX and RX audio are separated from each other (that is, the TX audio is carried over a separate pair of wires from the RX audio). The device that converts the 2-wire analog audio to 4-wire analog audio is called a “hybrid” (see Figure 1 below). Although hybrids are designed to minimize reflection, they cannot completely eliminate it.

Figure 1: Reflection at a Hybrid

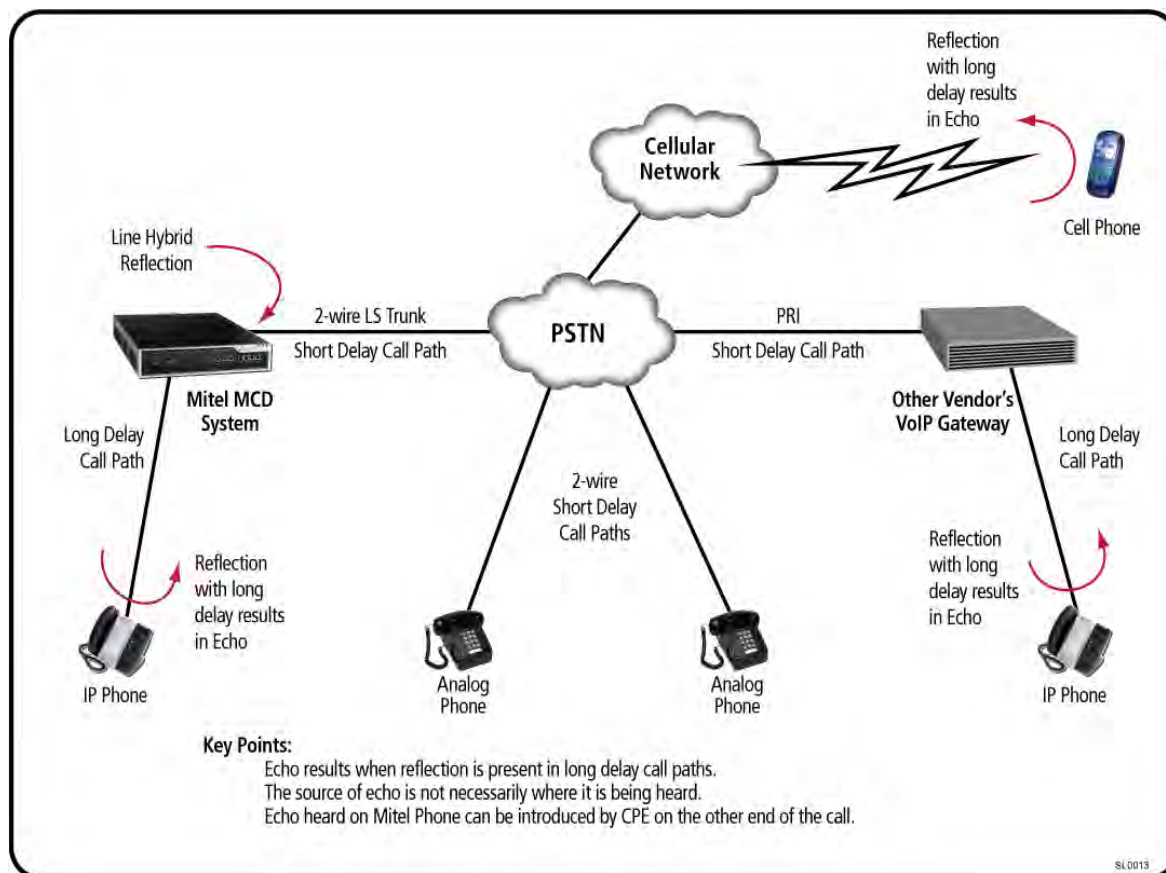
It is important to note that the source of echo is not necessarily where it is being heard. Echo that originates in the CPE on one side of the PSTN might be heard in the CPE on the other end. You must educate your customer so that they understand that although echo is being heard on a Mitel phone, the echo may in fact originate in another vendor's CPE on the other side of the PSTN.

Figure 2 illustrates how echo can originate in CPE on either site of the PSTN:

Figure 2: Echo Originating in Customer Premise Equipment

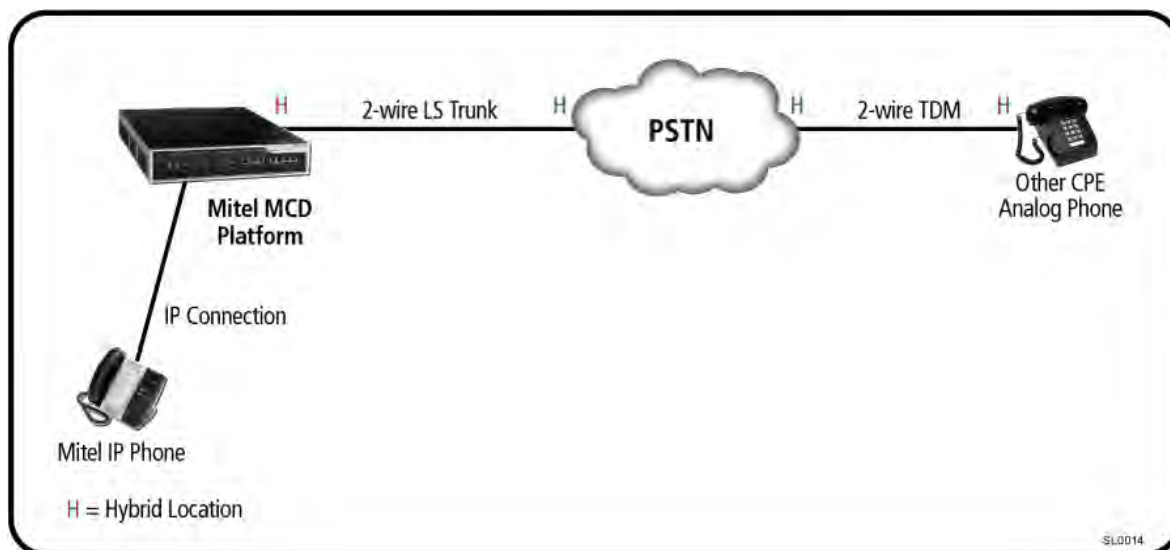
In Scenario 1, a Mitel IP phone is connected via IP to the MCD platform which is connected to the PSTN via 2-wire, Loop Start (LS) trunk. The MCD platform is also connected to the PSTN via 2-wire TDM.

Figure 3: Scenario 1

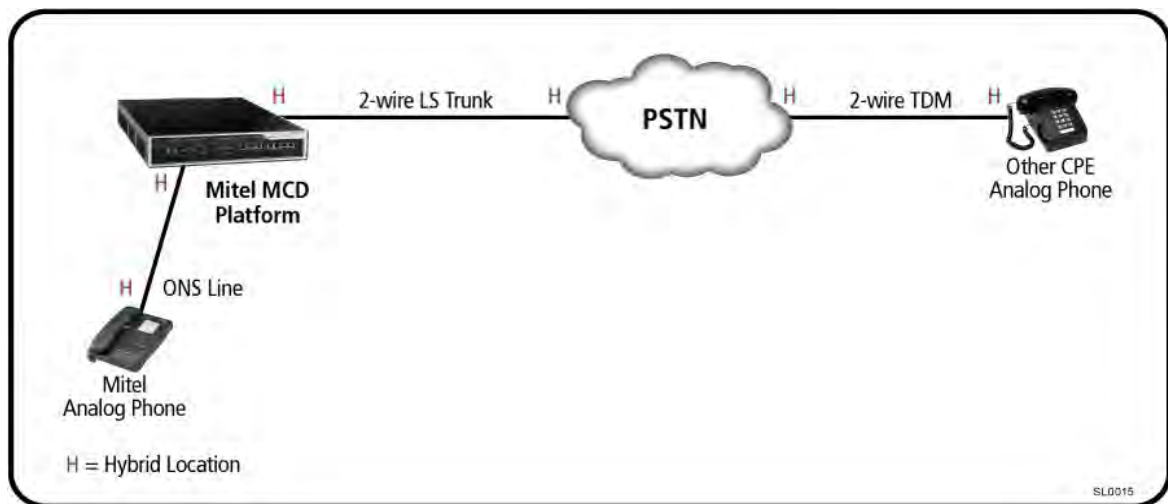
In scenario 2, an analog phone is connected to the MCD platform via a 2-wire ONS line; the MCD platform is connected to the PSTN via 2-wire LS trunk. The MCD platform is connected to the PSTN via 2-wire LS trunk.

Figure 4: Scenario 2

2. The ONS line on the MCD platform does not introduce any significant delay that could cause echo. Therefore, you are not responsible for cancelling reflections from entering the PSTN for the benefit of the CPE 2-wire analog phone on the other side of the PSTN.

6. There are three hybrids in the Mitel CPE that cause reflections in the direction of the PSTN 2-wire analog phone. Since the delay through the MCD system is short, these three reflections cannot be distinguished from a single reflection and can be handled by the PSTN as if they originated from a single two-wire phone hybrid.

7. The 2-wire analog phone may generate acoustic, mechanical, or crosstalk reflections. Normally the levels of these reflections are much lower than the hybrid reflection, with approximately the same delay, so no acoustic echo canceller or suppressor is needed. However, if the 2-wire set has a handsfree mode, echo suppression will be needed because of the louder levels and the additional delays caused by longer acoustic echo paths.

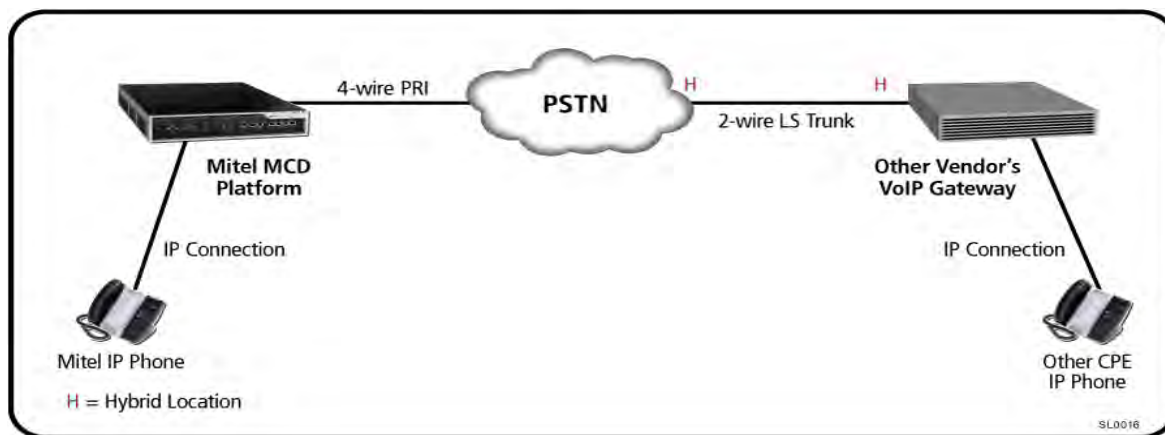
In scenario 3, a Mitel IP phone is connected via IP to the MCD platform; the MCD is connected to the PSTN via PRI trunk; the PSTN is connected to a VoIP Gateway via LS trunk; and a VoIP phone is connected via IP to the gateway.

Figure 5: Scenario 3

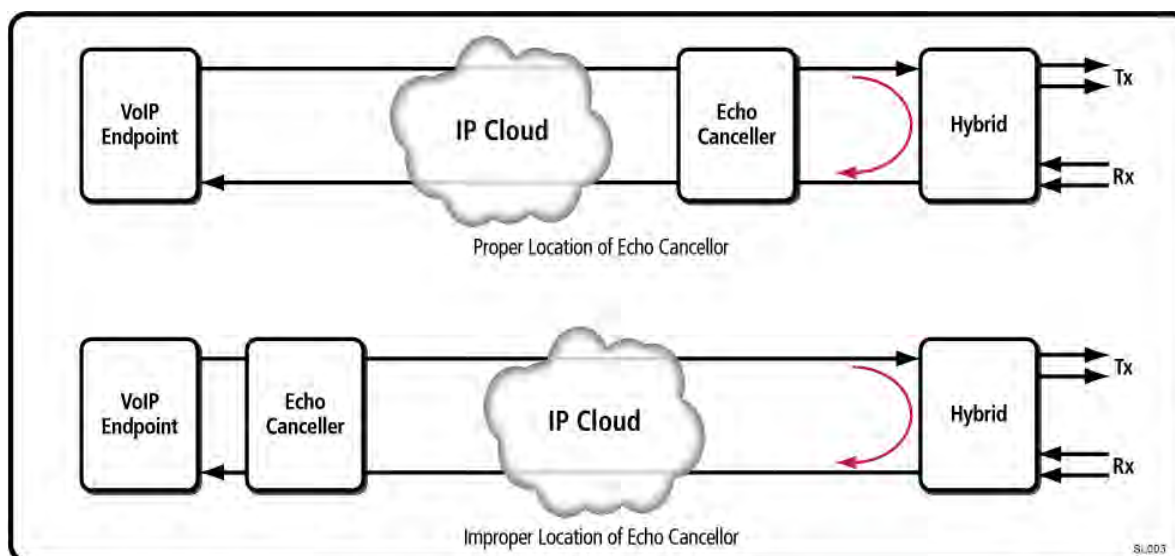
This explains why echo cancellers must always cancel echo in the circuit-switched network before the echo enters the IP cloud. After the echo enters the IP cloud, the echo canceller cannot cancel echo effectively when it exits the IP cloud. See Figure 6 for an illustration.

Figure 6: Echo Cancellor Location

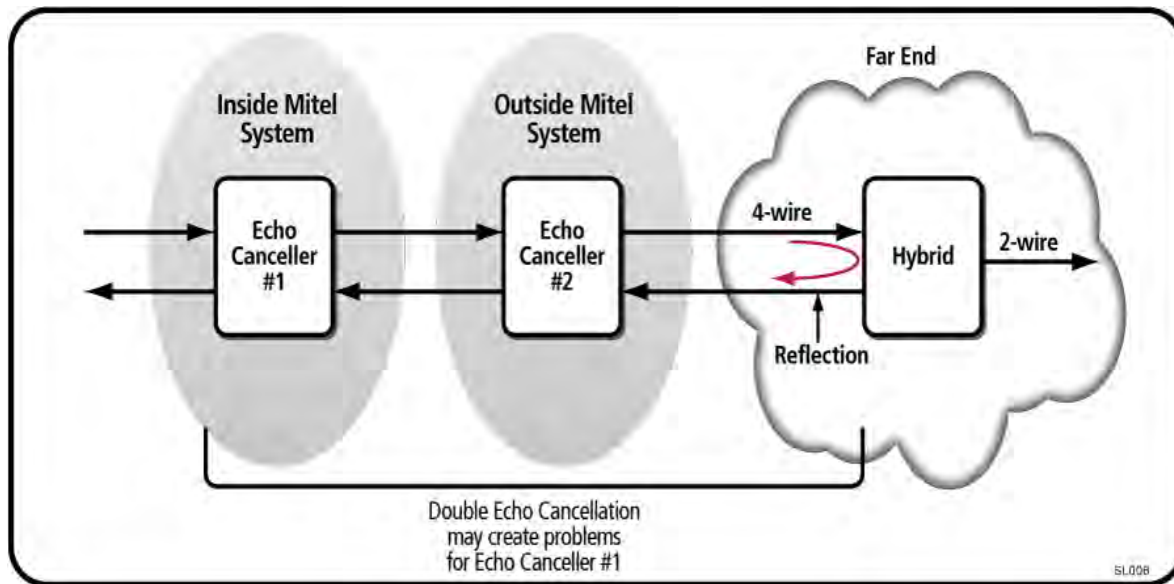
In Figure 7, if echo canceller #2 is functioning correctly, echo canceller #1 will never have a chance to adapt and there will be little impact on audio quality. However, if echo canceller #2 sometimes allows echo to pass, the echo canceller #1 will try to adapt. This scenario could cause voice quality issues.

Figure 7: Double Echo Cancellation

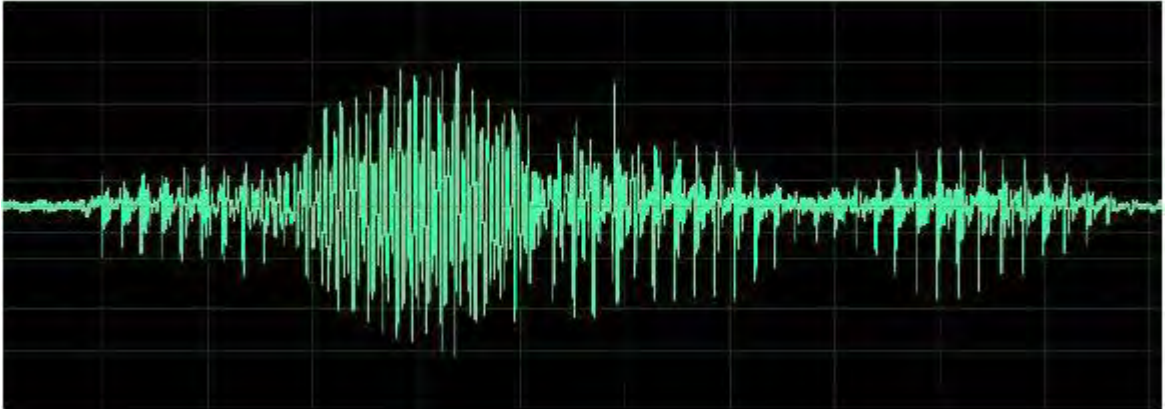
talking. This situation can happen if the speaker has a loud, deep voice that saturates the signal. Users will often report saturated audio as echo. See Figure 8 and Figure 9 for examples of normal and saturated audio.

Figure 8: Normal Audio Sample

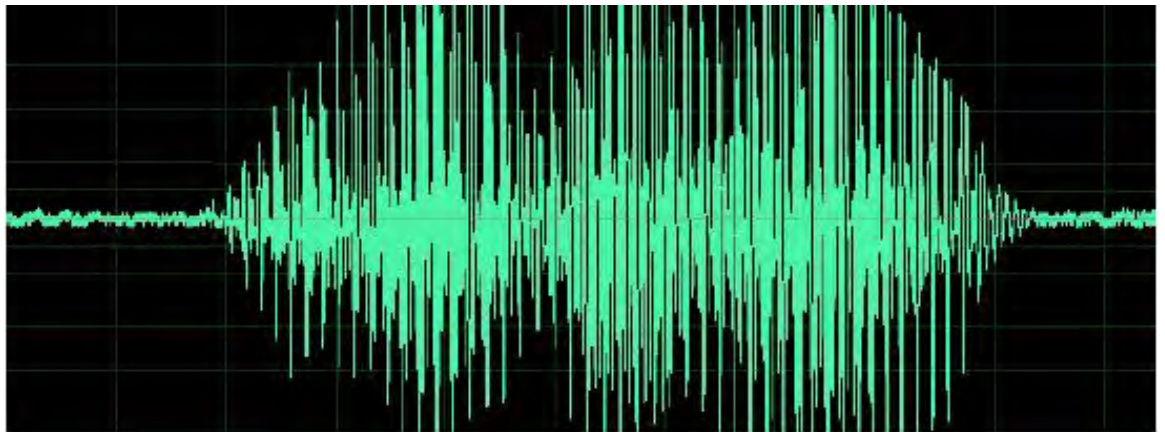
Figure 9: Saturated Audio Sample

The issue is occurring on . . .	Probable Cause	Corrective Action
Multiple IP phones on calls across LS trunks.	Excessive echo suppression in the network.	Run the Line Measurement Tool (see page 56) to apply correct settings.
Phone in handsfree mode.	Speakerphone volume is too high.	Reduce volume of speakerphone.
Calls involving a specific user.	User is speaking into the phone using a particularly loud and low voice.	Use a Network Traffic Analyzer, such as Wireshark, to capture a sample of the audio at both ends of the call. Compare the samples. If the sample from one caller appears saturated (see Figure 9 for an example), instruct the caller to speak in a normal tone of voice.

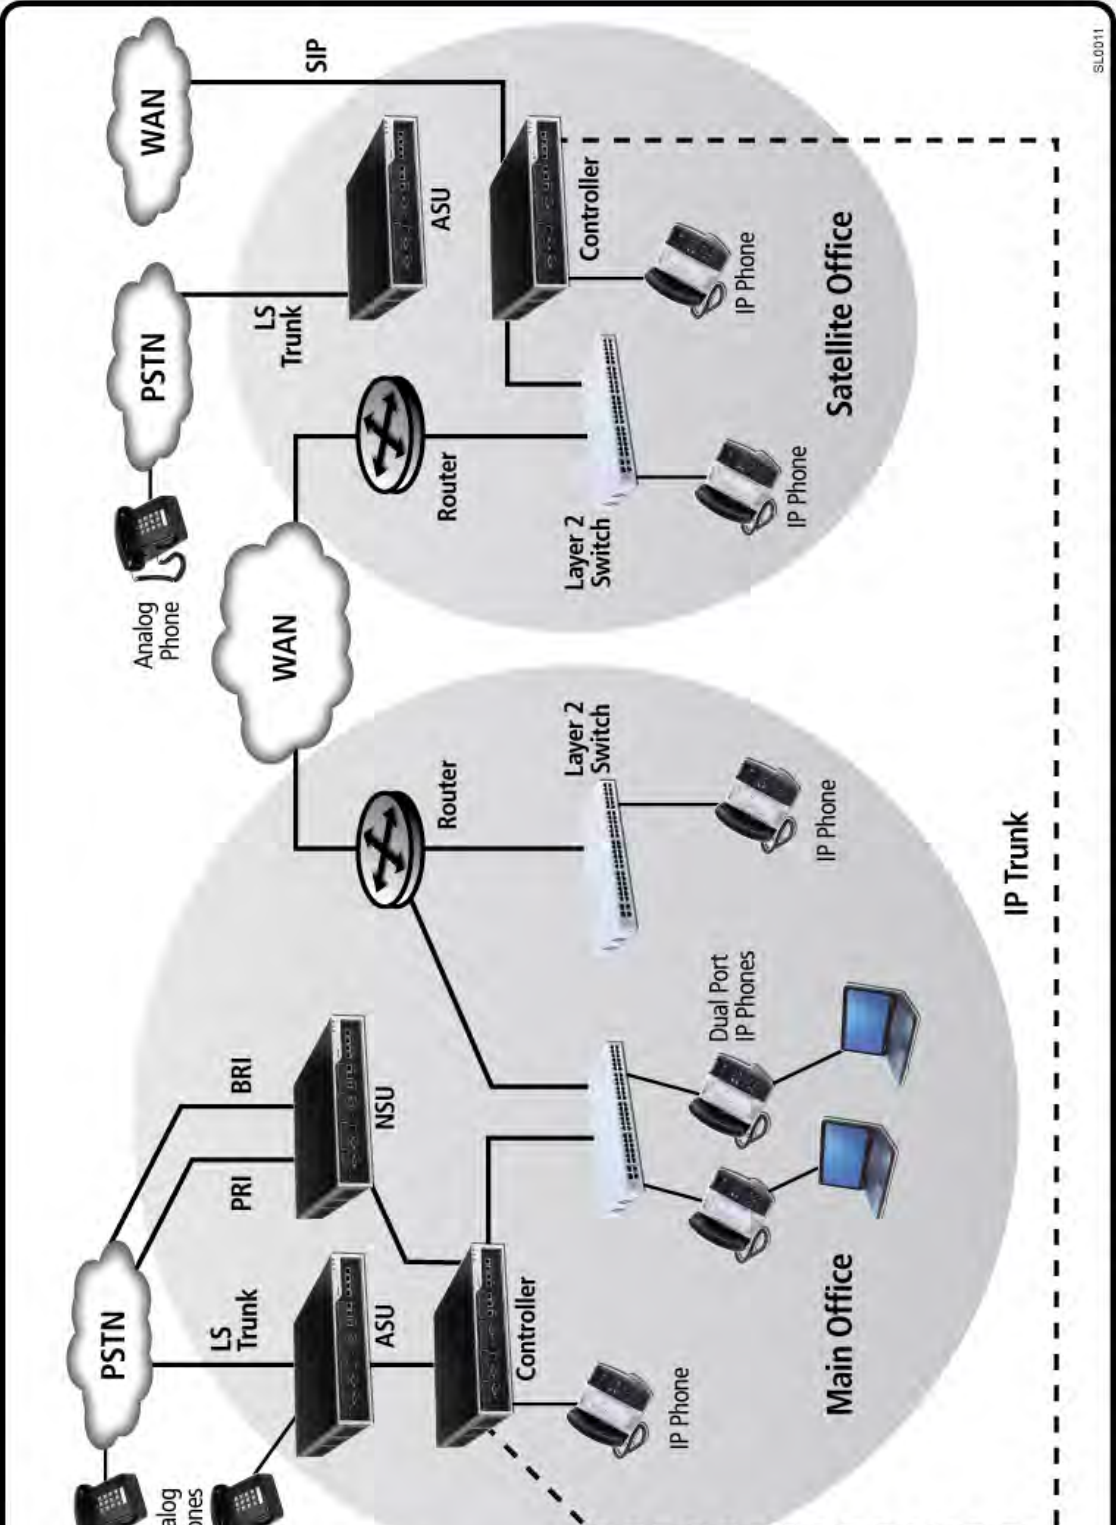
Figure 10: Example of a Simple Network Diagram

Figure 10 provides an example of this troubleshooting methodology. By placing calls to different destinations, you determine that the voice quality issue is not present on calls

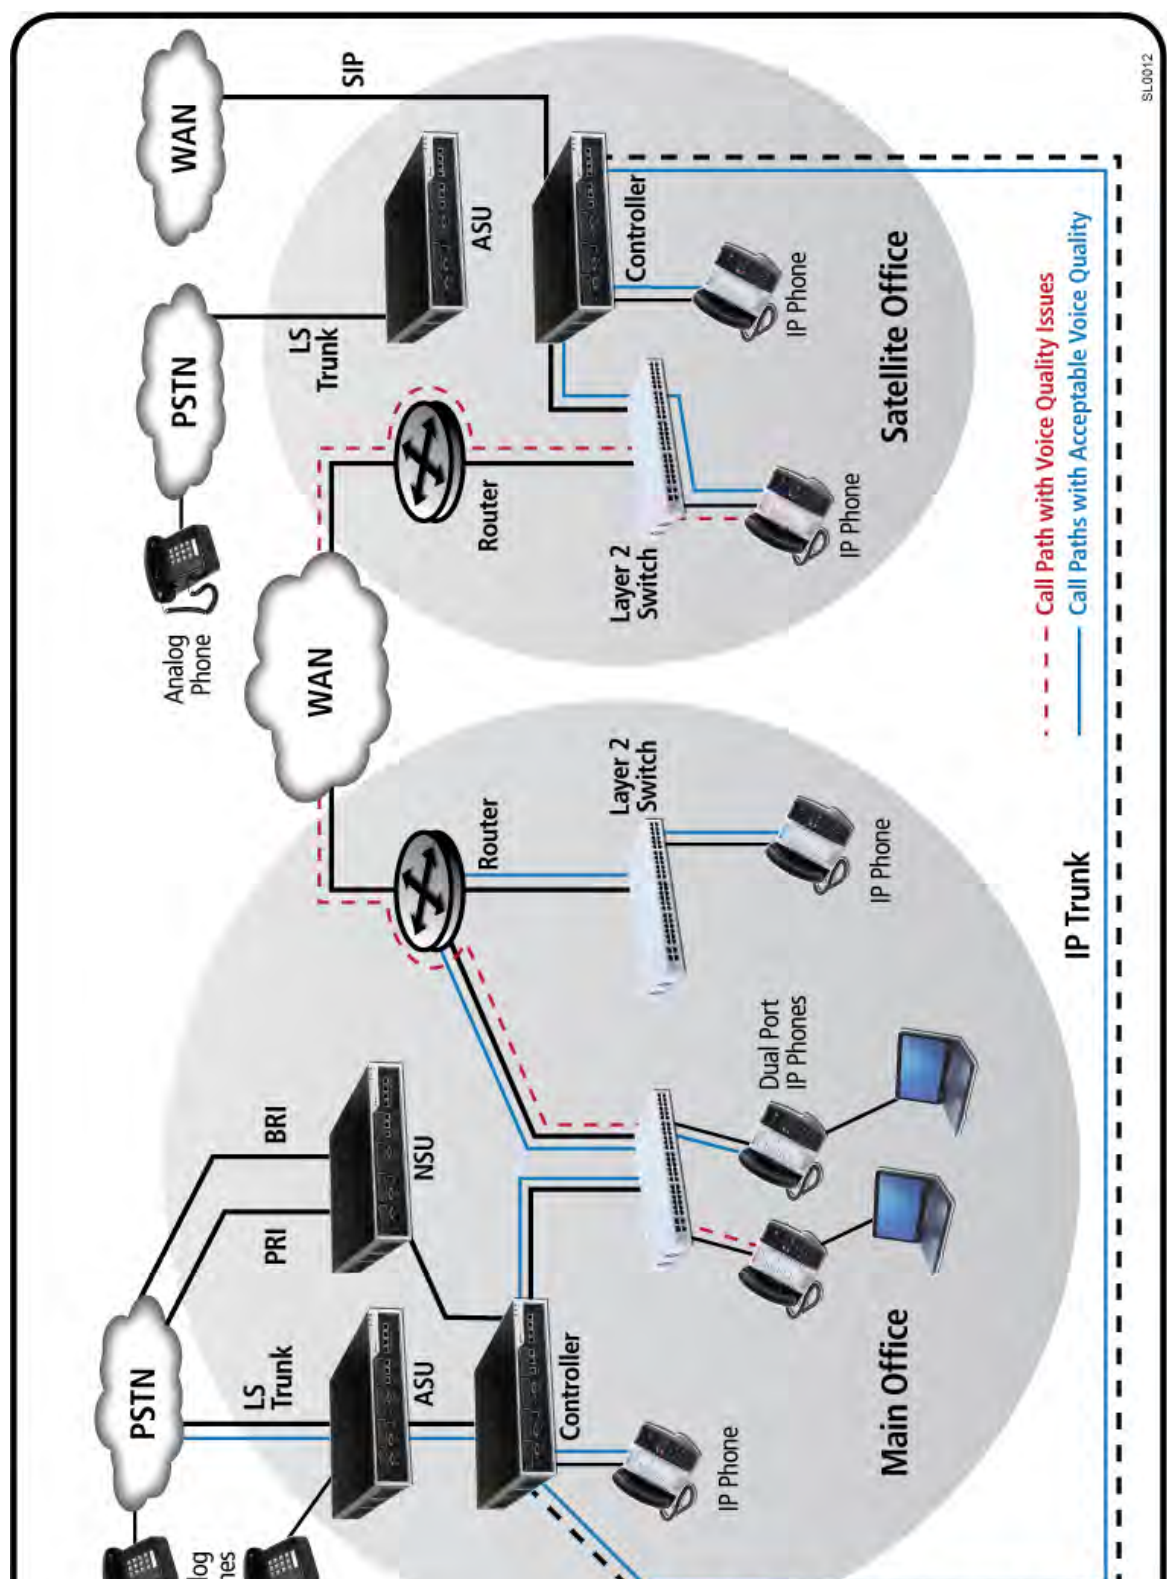
In this example, you determine that the voice quality issue occurs only on VoIP calls between IP phones located in the main office and those in the satellite office. In this case, you would focus your troubleshooting on the

- routers at the network edges
- available bandwidth and traffic occurring on the path
- controller in the satellite office.

Figure 11: Example of Isolating Voice Quality Issue

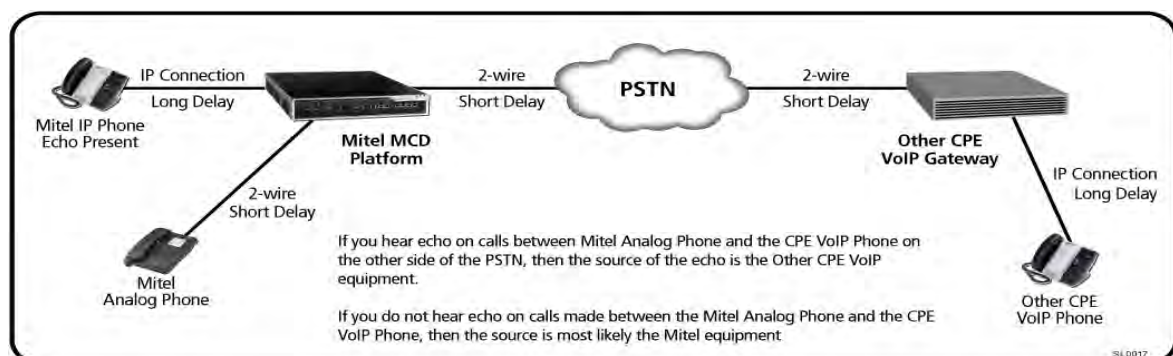
- If you hear echo, the customer premise equipment on the other side of the PSTN is the source. The echo must be corrected in the CPE on the other side of the PSTN.
- If you do not hear echo when you call from a Mitel analog phone, the MCD equipment is likely the source and the echo must be corrected in the Mitel equipment.

Figure 10 illustrates these two possibilities:

Figure 10: Identifying the Source of Echo
